# **EXPERIENCE IN THE APPLICATION OF PERMEABLE INTERLOCKING CONCRETE PAVING IN AUSTRALIA**

## **Summary**

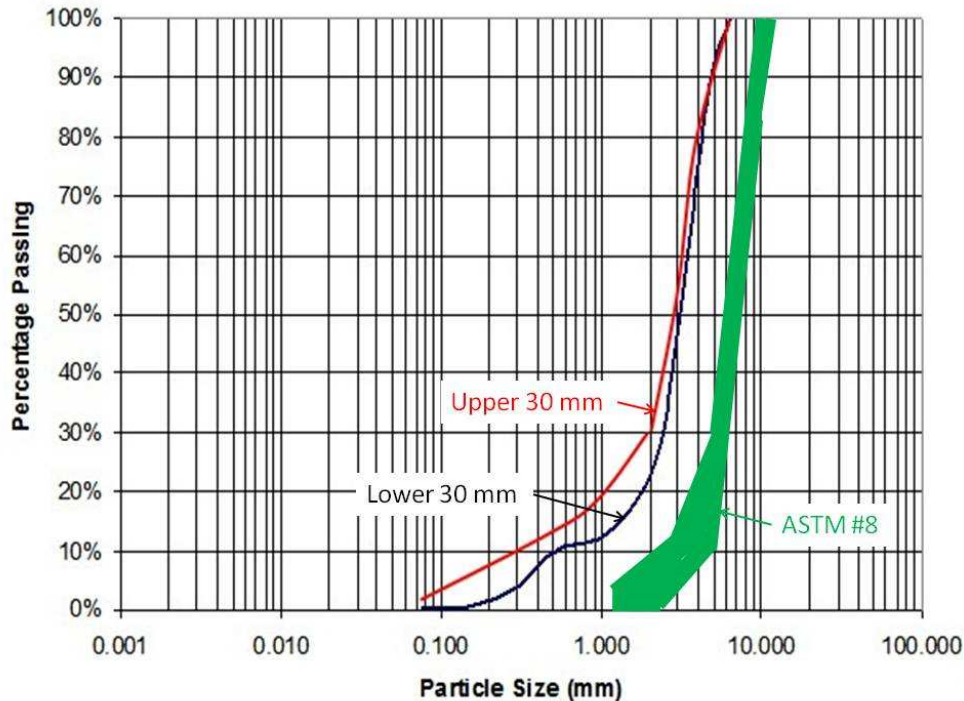
Figure 2. Typical Gradings for Upper and Lower Jointing Material.

Based on Australian research [Shackel et al., 1996; 1997] it is customary in Australia to specify jointing materials for PICP as a clean uniform 2 mm to 5 mm aggregate, similar to the US ASTM #9 gradation. Few specifications or construction records remain for the pavements shown in Table 1. However, from the sieve analyses, it was found that the jointing materials generally had a maximum particle size of approximately 6 mm to 7 mm with 10% or more passing the 1.18 mm sieve and up to approximately 5% passing the 0.3 mm sieve size. This meant that the gradations typically lay towards the fine limits of an ASTM #9 grading. As such the jointing materials were all significantly finer than the ASTM #8 grading commonly specified in North America (see Figure 2).

At 10 of the 14 locations it was found that there were more fine particles in the upper 30 mm than in the lower 30 mm to 60 mm of jointing material. The results are shown in Figure 2. These indicate that the increase in fines generally occurred in the particle size range of 0.2 mm to 2.0 mm.

Of the samples showing little change in grading between the upper and lower portions of jointing material, one was from an area swept immediately prior to sampling at Smith Street, Manly, while two were from Olympic Park where mechanical sweeping was used routinely. The fourth sample was collected near a tree on the Karrabee Avenue parking area for which the maintenance history is unknown. The jointing material sampled from areas known to have been swept showed no change in fines between the upper (0 mm to 30 mm) and lower jointing depths (30 mm to 60 mm). This indicates that most of the fine clogging materials observed in the upper depths of the joint material for unswept pavements would have been located immediately at the top of the joints, i.e. from where it could easily be removed by sweeping.
