PERFORMANCE REVIEWS OF HONG KONG INTERNATIONAL AIRPORT AND YANTIAN INTERNATIONAL CONTAINER TERMINALS

Claudia Yun Kang, P. Eng.

SUMMARY

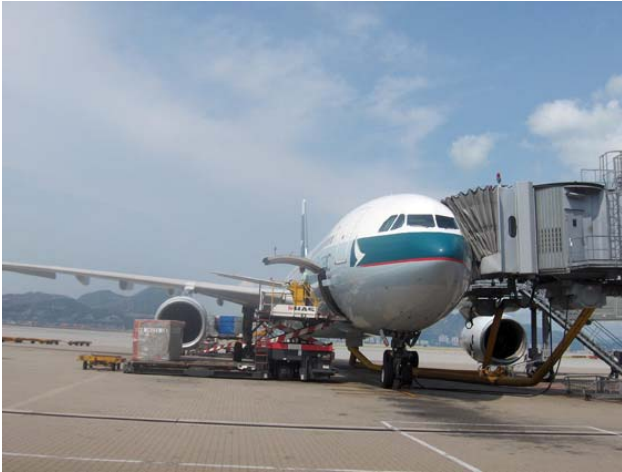
Figure 3. Passenger Aircraft Apron (HKIA)

It was observed that the concrete block pavement at the aircraft aprons is generally performing well, with no evidence of any significant pavement distress. There was evidence of oil spillages from service vehicles and possibly from aircrafts, but the surface of the blocks appeared unaffected with no evidence of any significant surface wear or defects. The surface flatness and smoothness of the

pavement appeared to be good. There were isolated broken blocks, possibly caused by impact loads from aircraft loading equipment. The joints were full and appeared to be sealed with no evidence of erosion of jointing material. Figures 3, 4 & 5 show the aprons at different locations.

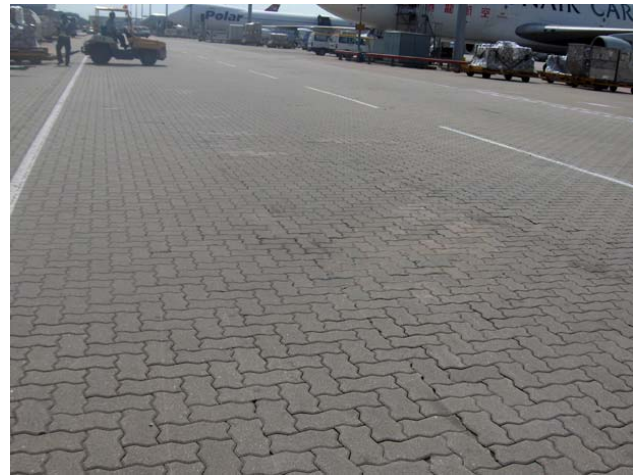
Figure 6. Defective Areas (HKIA)

In the traffic areas adjacent to the terminal building and aprons, some minor deformations were found. The defective areas are less than 1m² in size and typically 10-20mm deep. They are randomly spread on the road surface as shown in Figure 6.

The pavement around the terminal building and passenger & cargo aprons was designed as "transition pavement" between piled structures that shouldn't settle and adjacent in-situ concrete pavement that may settle. The concrete block pavement contains a significant number of service trenches, service pits, and manholes. These areas were recognized from the outset that they would endure the most differential settlement and the most traffic from service vehicles and aircraft tugs, the latter having significant axle loads and would require a high maintenance level. As anticipated, most defects and repairs were concentrated on these areas.

However, the defects at these locations should be fully investigated to establish the cause or causes.

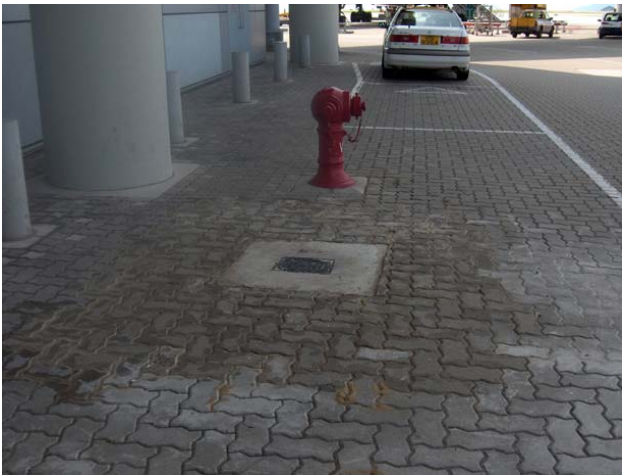
Figure 7. Maintenance at Service Pits (HKIA)

The defective pavement at some service pits has been brought back to the correct level, as shown in Figure 7.

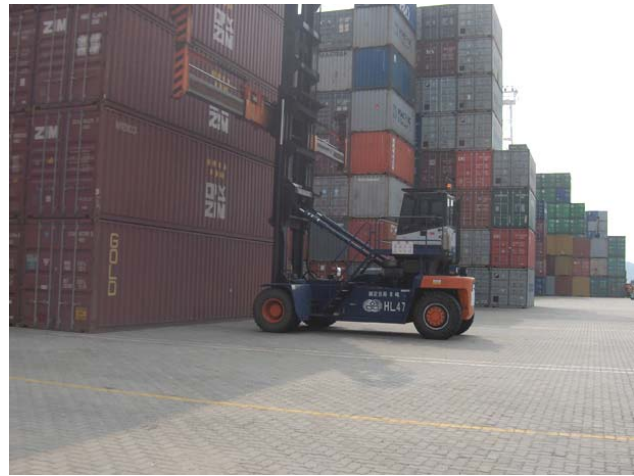
Figure 8. Container Yard (YICT)

In general, the block pavement are performing well (refer to Figure 8). No deformation and surface wear were found in this area except for some broken blocks at container corners possibly caused by impact load. Debris and detritus were found to be ground into the joints and the surface of block pavement as shown in Figure 9. Judging from their appearance, blocks at the location of some of the container corners appeared to have been broken for some time but they didn't appear to adversely affect the structural integrity of the pavement.

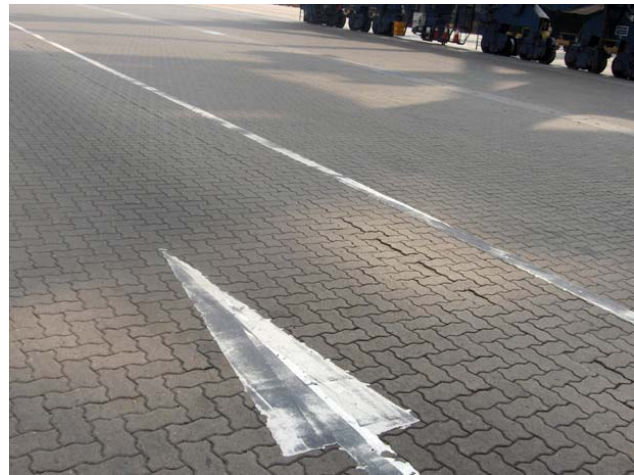
Figure 10. Defective Area (YICT)

There are isolated areas of minor longitudinal and to a lesser extent transversal ruts on access ways as shown in Figure10. Typically these ruts are 300mm wide by 20mm deep and may indicate localised failures at locations of the joints between the lean mix paver runs.

When they repaired these defective areas, they normally jack-hammer out the top one-third of base and use C20 concrete to fill back to the correct levels, then reinstate the block layer. However, in some areas this practice has created an additional problem in that at the location of the joint between the new C20 and existing base some further failures occur after a certain period of traffic.

To solve the problem of failures of C20 repaired areas it may be desirable to investigate the cause of this. It would be important that the repair concrete is full depth over the entire area of the repair and is not tapered down which may result in weakness. Perhaps the perimeter of the repaired base should be saw-cut full depth to ensure a constant thickness of the repaired base.
