LAYING COURSE SAND FOR CONCRETE BLOCK PAVING

A.A. Lilley, M.Phil., C.Eng., MICE, FIHT - Consulting Engineer
(A.J. Dowson, B.A., T.Eng.) (C.E.I.), M.I.G., Tech.E.

MARSHALLS MONO LIMITED

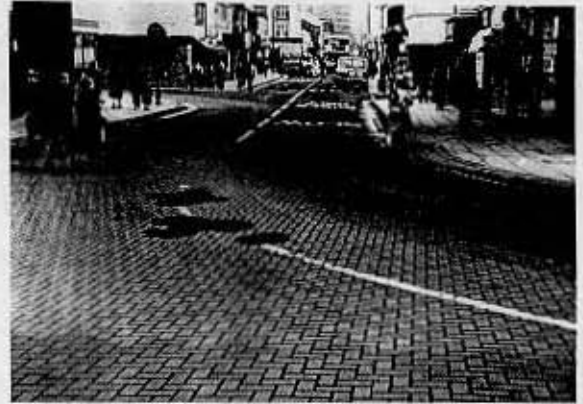
be built up. The block paving construction followed normal practice, which had been used very successfully on many other bus stations. After some 18 months of use, depressions appeared in the surface of the paving. With the co-operation of the employing authorities the cause of these was investigated by carefully lifting the blocks and the laying course to expose the roadbase.

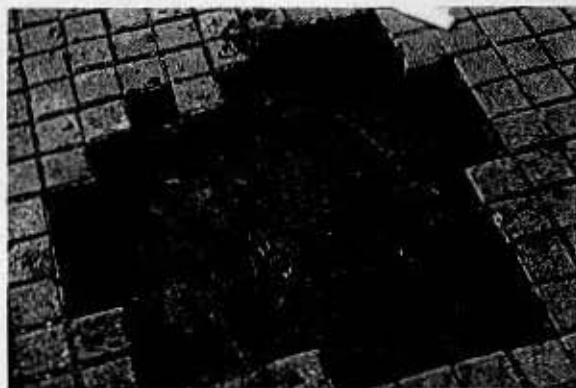
The blocks were removed carefully and individually without disturbing the laying course, which was found to be hard and well compacted. Depressions in the laying course reflected depressions in the surface. The sand was also seen to be stained to a dark colour in the location of the joints of blocks, see Figure 7.

The sand was then removed and found to be formed into a biscuit-like structure, individual sand grains being bonded together. Away from the joints the sand was found to be its original colour, but towards the bottom of the layer further staining was observed. Samples were sent away for further analyses.
