Surface Infiltration Improvement of Highly Clogged Permeable Interlocking Concrete Pavements

David R. Smith¹ and Robert Bowers, P. Eng.²

Abstract

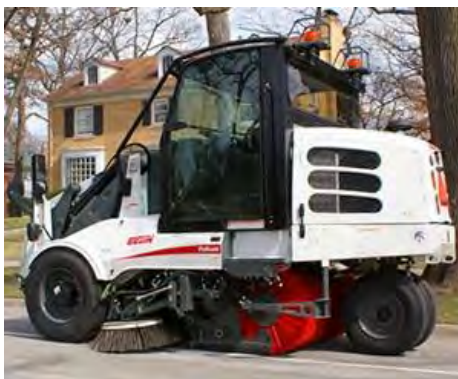
Figure 1. Street sweeper

The primary purposes of permeable pavements are reducing stormwater runoff and filtering sediment while providing pedestrian or vehicular pavement. Permeable pavements require regular cleaning to remove accumulated sediment from the surface. This is achieved by applying water while vacuuming their surfaces. According to Eisenberg [1], there are at least three types of cleaning equipment: (1) a mechanical sweeper generally used with no vacuum force, (2) regenerative air that recirculates air rapidly to create a vacuum force within a intake orifice about 2 m wide, and (3) a true vacuum which operates like a large-sized home vacuum cleaner with a orifice approximately a meter wide. Examples of these machines are illustrated in Figures 1, 2 and 3.

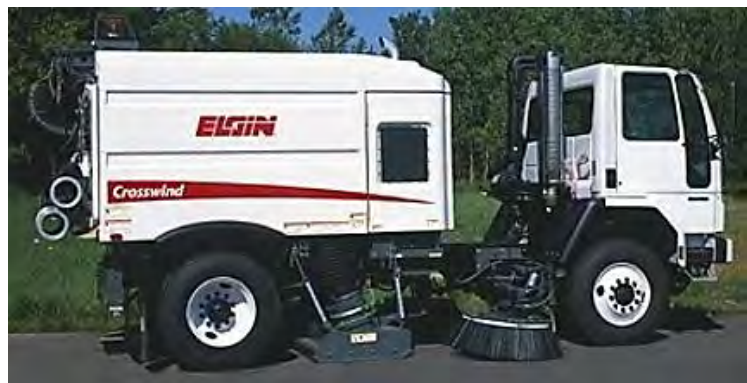
Figure 2. Regenerative air

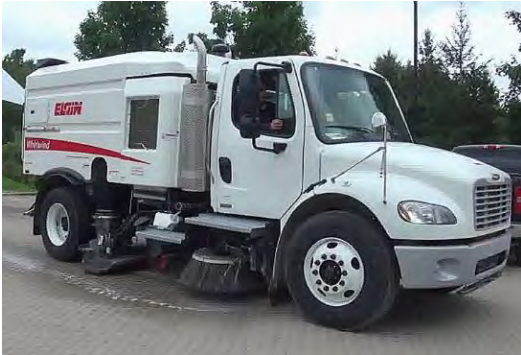
Figure 3. True vacuum machine

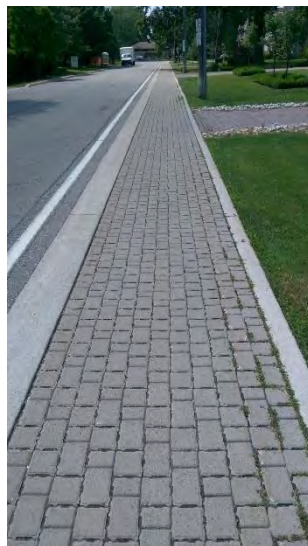
Figure 7. Gregwood Road, Mississauga parking lane – 8 passes, ~5 years old

The following figures illustrate the PICP sites. Some show the extent of impervious pavement contributing runoff into the PICP. The number of passes of the Cyclone equipment are indicated.

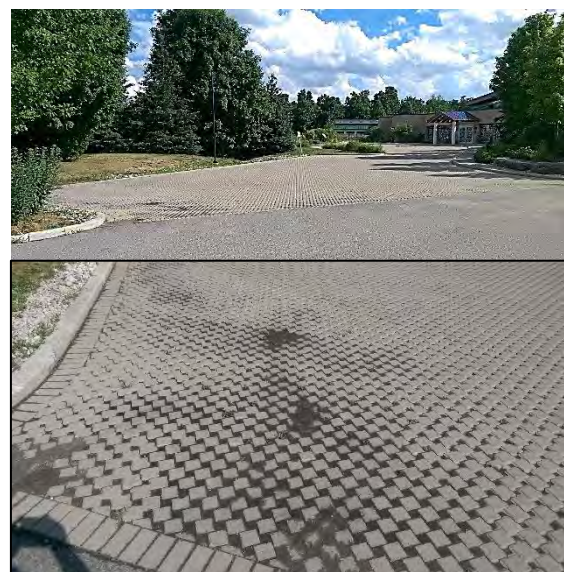
Figure 8. Kortright Center entry – 14 passes, 10 years old

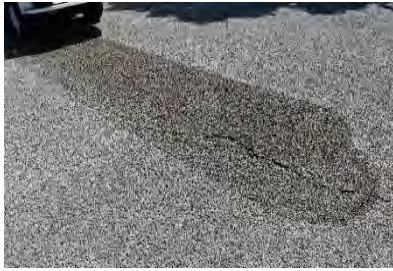
Figure 9. Kortright Centre, parking lot, Vaughan, 6 passes – 8 years old

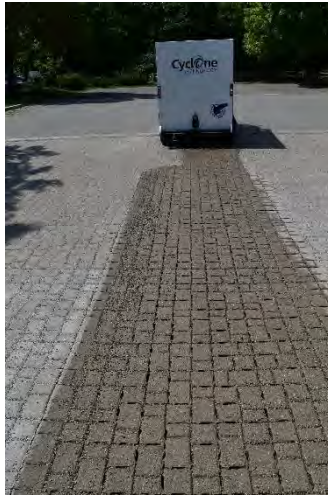
Figure 10. Kortright Centre, parking lot, Vaughan, 6 passes – 9 years old

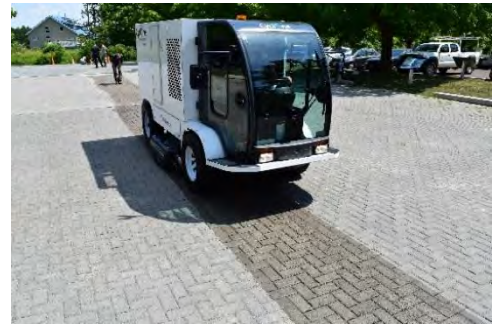
Figure 11. Kortright Centre parking lot, Vaughan, 6 passes – 9 years old
Figure

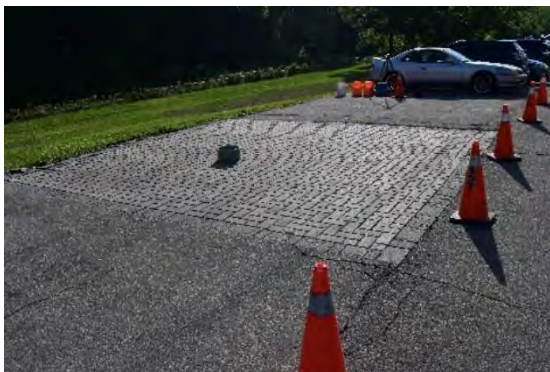
Figure 12. Walter Fedy AEC, Kitchener – 3 years old, 8 passes

The sites shown in Figure 12 and 13 were cleaned with 8 passes of the Cyclone equipment, Figure 14 with 10.

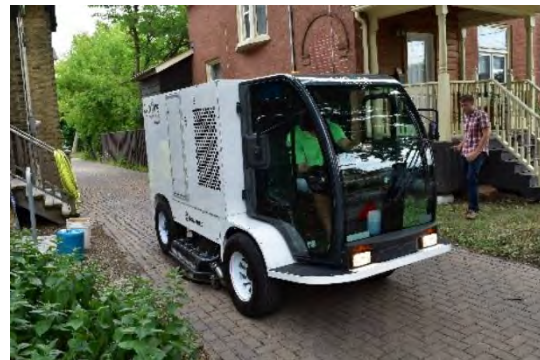
Figure 13. Driveway/parking lot on Mill Street, Kitchener – 9 years old, 8 passes

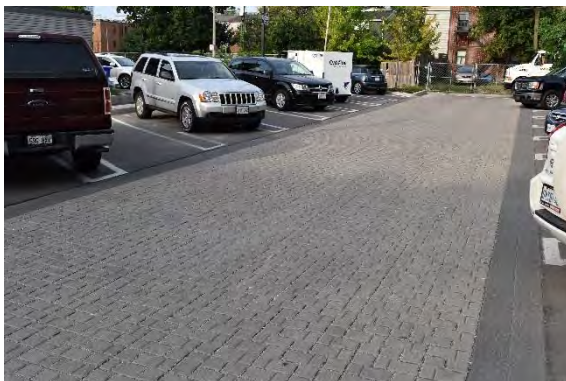
Figure 14. Broadview Avenue, Toronto – 5 years old, 10 passes

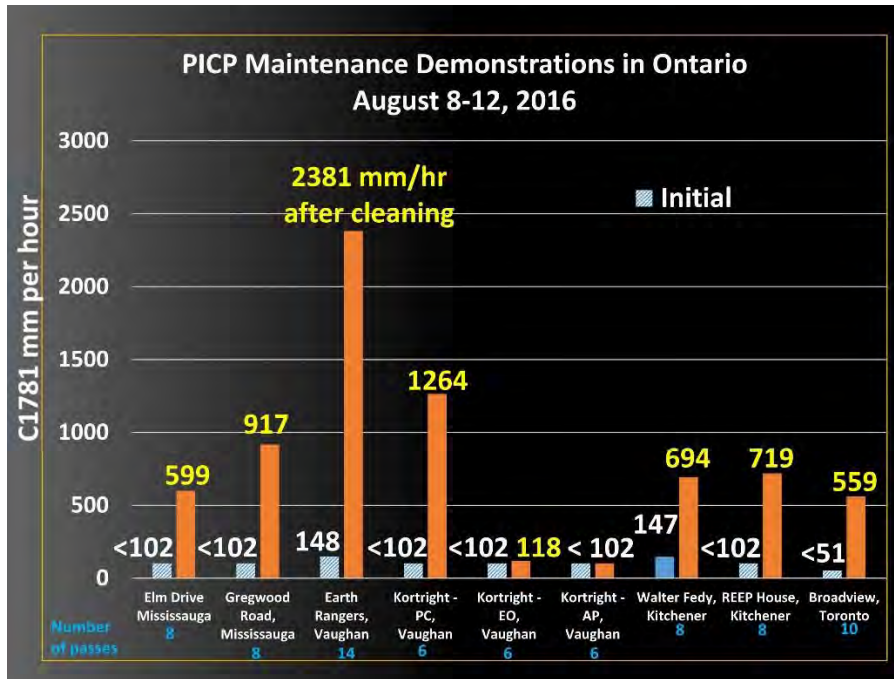
The surface infiltration rates before (initial) and after cleaning are shown in Figure 15. All of the post-cleaning infiltration rates do not meet the minimum 2500 mm/hr recommended by ICPI. Two PICP sites at the Kortright Centre may have been previously clogged by using a pressure washer in an attempt to remove sediment. The low post-cleaning infiltration rates suggest that pressure washing may have moved sediment deeper into the pavement.

Figure 15. Pre- and post-vacuuming cleaning

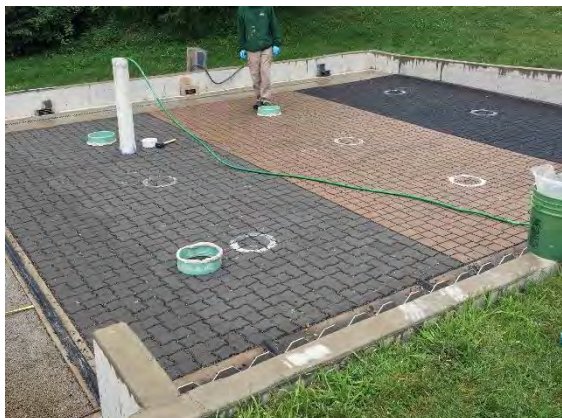
The experimental design with a 10:1 CDA from the asphalt parking lot delivers sediment from the asphalt. While not recommended for permeable pavement projects, this experiment intentionally accelerated the clogging of the surface with the 10:1 CDA ratio in order to measure the sediment trapped in the surface and structure. After loading the surfaces with sediment, and monitoring concentrations for one year, the surfaces were cleaned with a Cyclone machine in 2017 and the contributing drainage area reduced to 5:1 to study differences in sediment loading. Surface infiltration rates were measured using ASTM C1701 *Standard Test Method for Infiltration Rate of In Place Pervious Concrete* as shown in Figure 16. This test method is similar to ASTM C1781, making data from each test method comparable. The white circles indicate surface infiltration measurement locations.

Figure 16. PICP surface infiltration measurement locations
