# ACHIEVING EXCELLENCE – LESSONS FROM RECENT PORT AND AIRPORT PROJECTS IN AMERICA

Design, construction, and maintenance aspects are reviewed for four airport and three port projects. The text incorporates information from technical papers, project specifications, designers, contractors, users, and involvement by the author on the projects. All were constructed between 1990 and 1994. All but one project is located in the U.S.A. It was designed and built by American engineers and contractors. The reasons for selecting interlocking concrete pavement are given. The projects demonstrate structural, maintenance, and life-cycle cost advantages of interlocking concrete pavements. Lessons from each are given on design, specification or construction. Most of these concern construction details. These lessons can be used to make more excellent projects in the future.

### *Dallas/Fort Worth (DFW) International Airport, Dallas, Texas - Taxiways 23, 27 and 29*

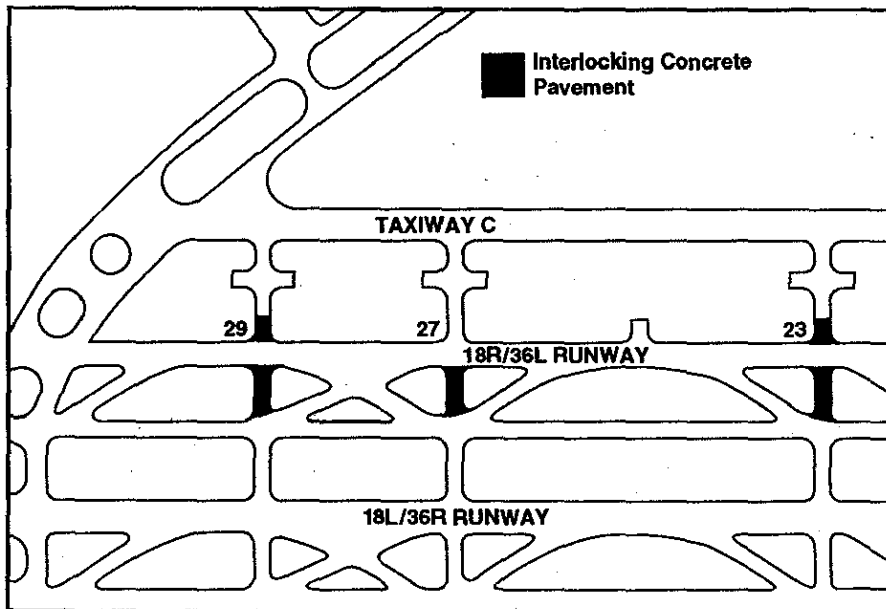
Figure 1. Location of Taxiways 23, 27 and 29 at DFW International Airport.

**Rationale** Construction of cross taxiways adjacent to 18R/36L runway at DFW airport required night time closure. Runway closure during construction had significant impact on air traffic, causing delays in both air and ground operations. Portland cement concrete (PCC) pavement normally used at DFW would require closures unacceptable to the airport and airlines. Interlocking concrete pavements were selected because they could reduce nightly closures from 14 to 12 hours over a 114-night construction period (1)(2)(3). DFW Airport represents the first use of interlocking concrete pavements in an airport application in the U.S.A.

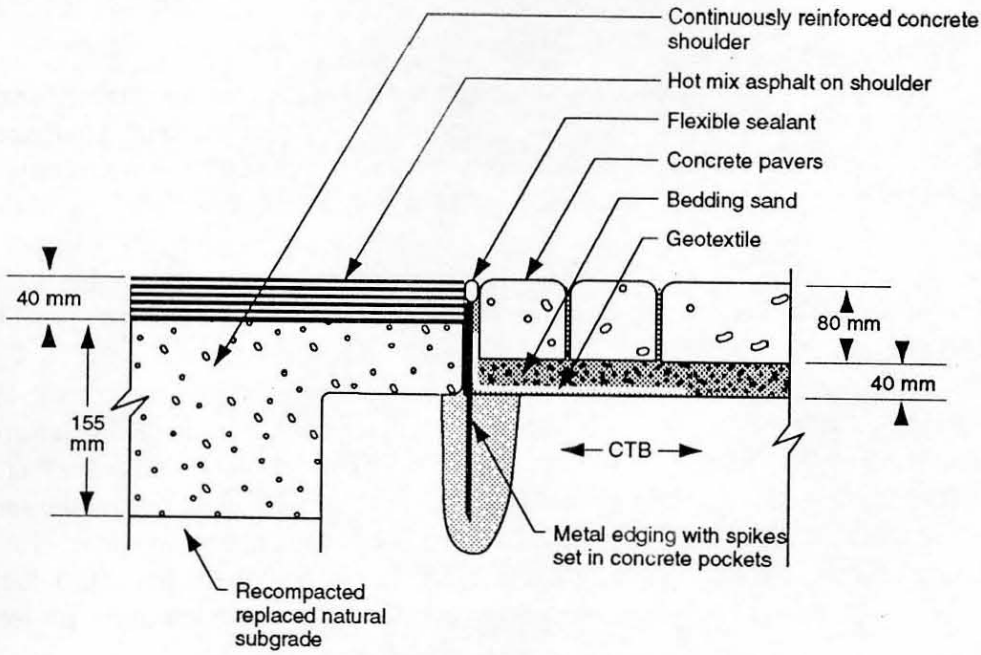
Figure 2. Repair to pavement edge at shoulders.

The most common distresses were loss of bedding sand along the edges of the pavement adjacent to concrete shoulders and to a lesser extent at the joints along the PCC pavement. Loss of sand at the shoulders was from heaving of the clay soils under them, since they were not stabilized with lime-flyash. In all the taxiway interiors, loss of bedding sand and depressed pavers mirrored paving lane joints in the CTB. No rutting, creep or swell was observed on the taxiways. In some areas of the taxiways, the joints have lost sand to a depth of 20-30 mm.

The study identified deficiencies in the subgrade stabilization in Taxiway 29, loss of bedding sand at the shoulders and at the junction with PCC pavement. Figure 2 illustrates the retrofit edge restraint for the shoulders. Figure 3 shows the repair to the paver-PCC joints with a steel angle. According to staff at DFW all repairs have been made to these edges.

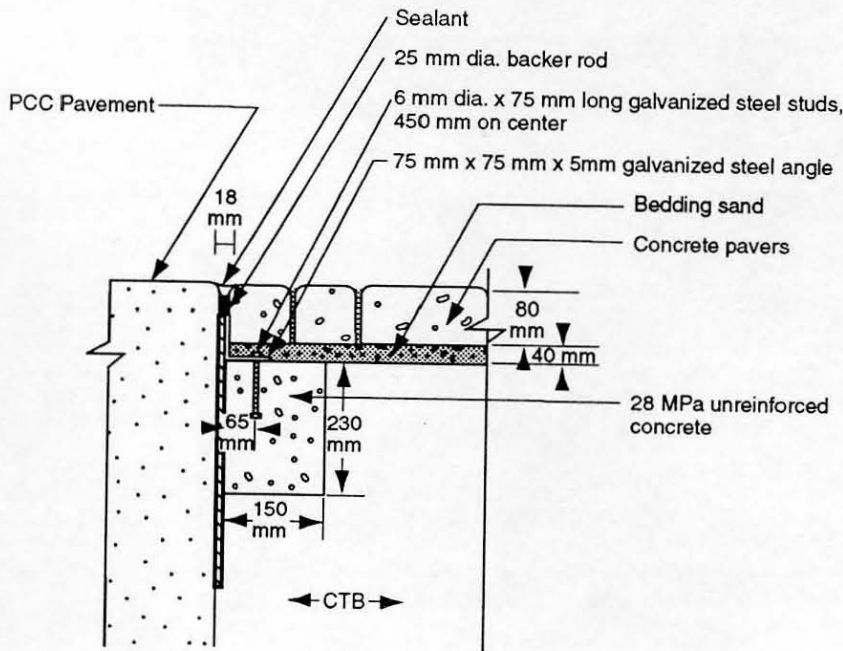
Figure 3. Repair to interlocking concrete pavement - PCC pavement joints.

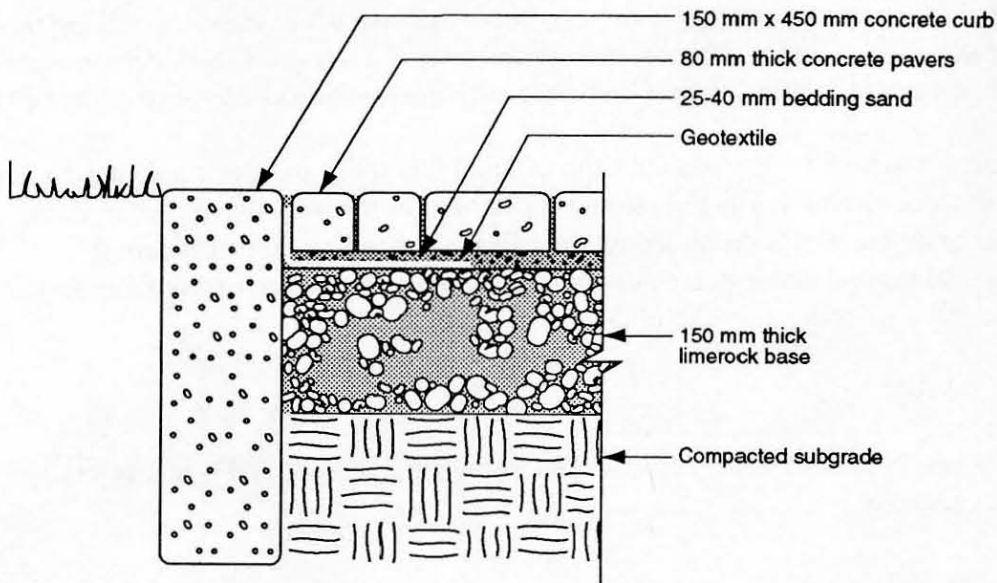
Figure 5. Use of geotextile to contain bedding sand at curbs.

**Excellence Achieved** Two construction details contributed to the excellence of this project. One was placing a 400 mm wide geotextile between the base and the curb. Figure 5 on the next page shows how this detail. It prevents migration of bedding sand between the base and the curb. It can decrease likelihood of settlement (13).

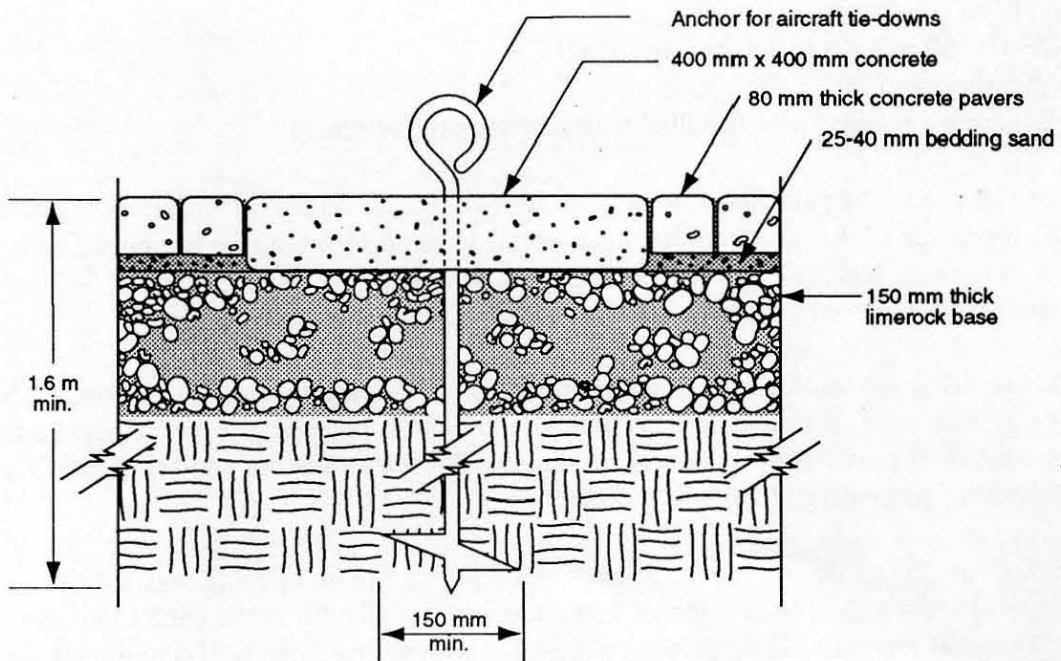
Figure 6. Detail of aircraft tie downs.

The second detail was the tie downs for the aircraft. An 400 mm square opening was left by removing installed pavers and bedding sand. A metal anchor was secured at the center into the base/subbase at regular intervals. The openings were filled with approximately 100 mm thick concrete. The anchors were connected with tie down lines. Figure 6 on the next page illustrates a tie down detail (9). Figure 7 on the following page shows the completed installation (13).

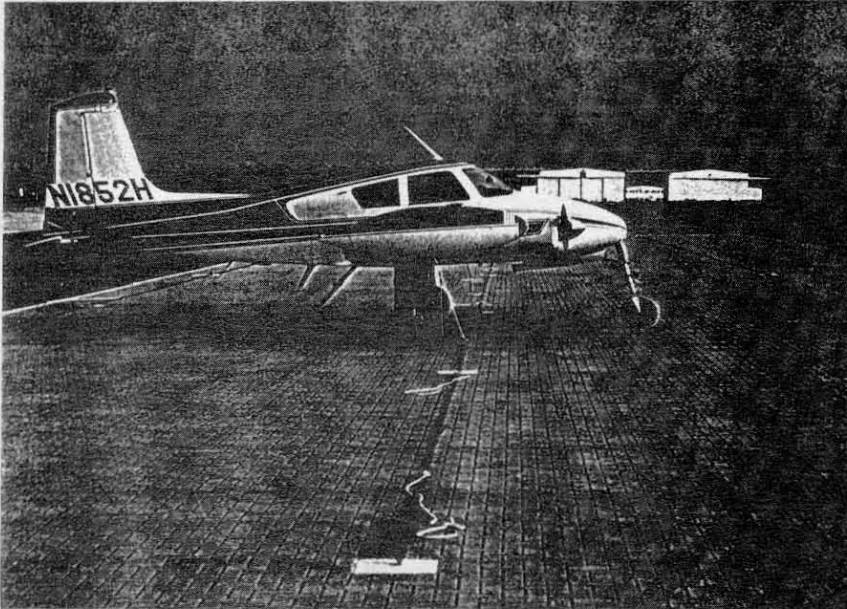
Figure 7. Aircraft tie downs in use.

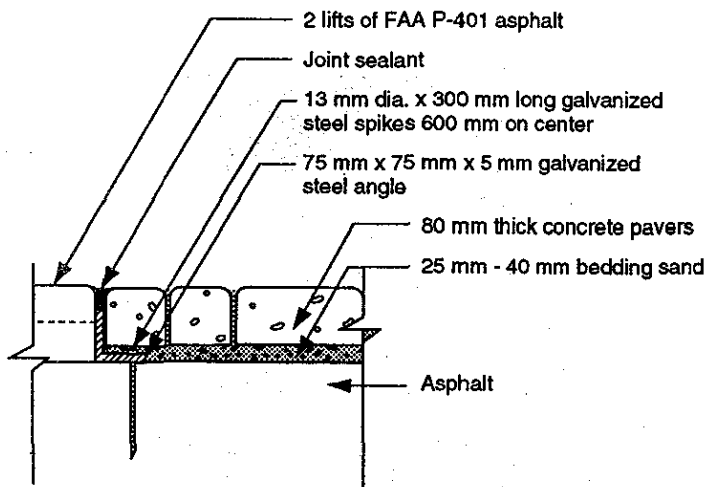
Figure 9. Edge restraint detail for overlay/inlay.

**Excellence Achieved** The edge details to restrain the pavers and bedding sand were developed specifically for contact against asphalt. Figure 7 shows this construction detail. A key to the success of this detail is paving the asphalt 60 cm past the location of the steel edge. The compacted asphalt is then saw cut back to the location of the steel edge restraint. Cutting and removing the excess asphalt ensures the highest compacted material adjacent to the concrete pavers and steel edge restraint.

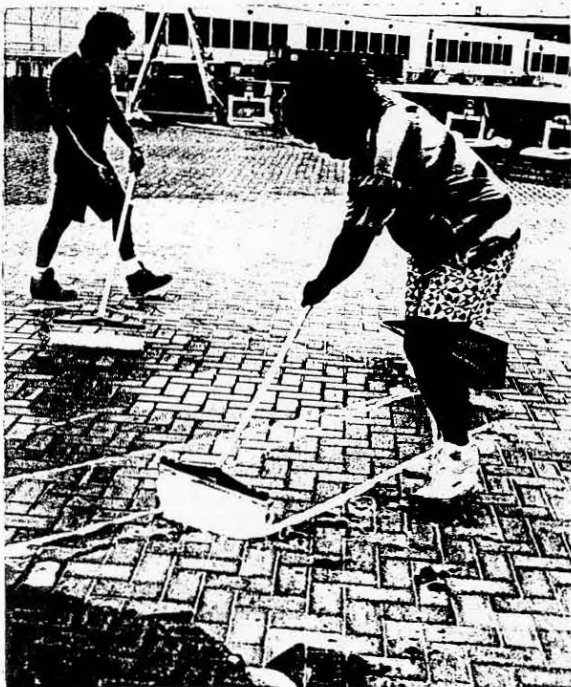
Figure 10. Applying urethane sealer.

An attempt to remedy the lack of drainage was made by placing five 100 mm diameter drain holes in the lowest elevations of each parking position. Urethane sealer was reapplied. This apparently has not allowed drainage of the bedding sand layer. Water fills the sand and causes the pavers to move under loads. In contrast to these distresses, snow plowing of the concrete pavers has presented no problems.

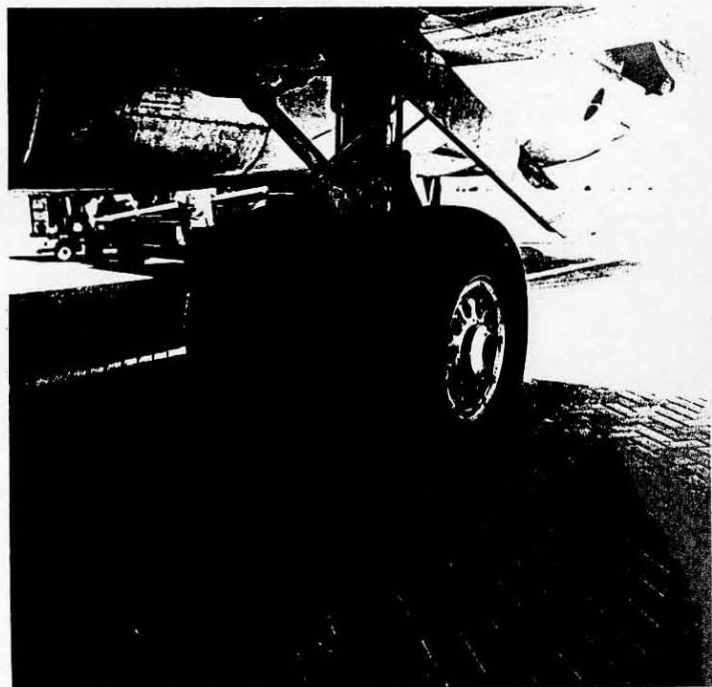
Figure 11. MD-80 wheels on the pavement.

**Performance** Movement in the pavers under the main gear and between the gear occurred soon after opening to jet aircraft. Depressions of about 15 mm formed under the main gear tires and pavers cracked under them. The movement of the pavers caused the joint stabilization material to break and allow excess ingress of water into the bedding sand. Lack of drainage of water in the bedding sand further exacerbated the movement of the pavers when loaded.

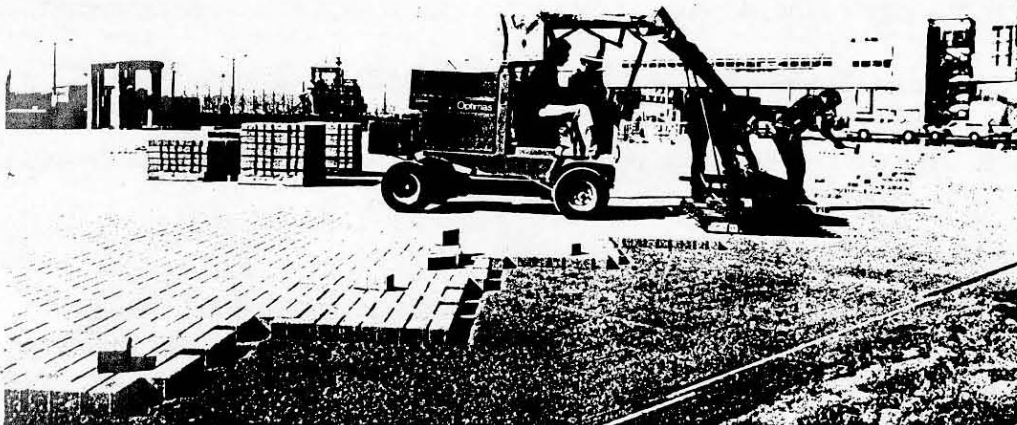
Figure 12. Mechanical installation at Berth 30, Oakland, California.

Interlocking concrete pavement was installed with mechanical equipment. The pavement was not proof rolled.

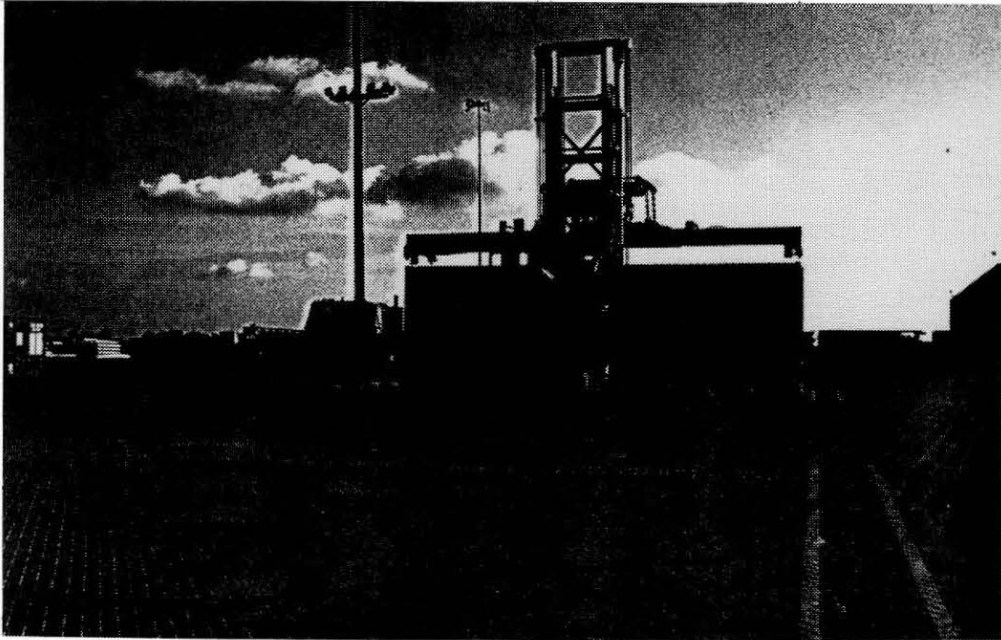
Figure 14. Typical container handling equipment at the Port of New Orleans.

**Loads** The pavements at New Orleans Yard B were designed for one million repetitions of 444 kN wheel loads from equipment for lifting and moving shipping containers (17).
