AN EXAMPLE OF PAVEMENT REHABILITATION BY CONCRETE BLOCK PAVING IN EXPANSIVE OR COLLAPSIBLE SOIL REGIONS

Moshe Livneh & karl Ruhm

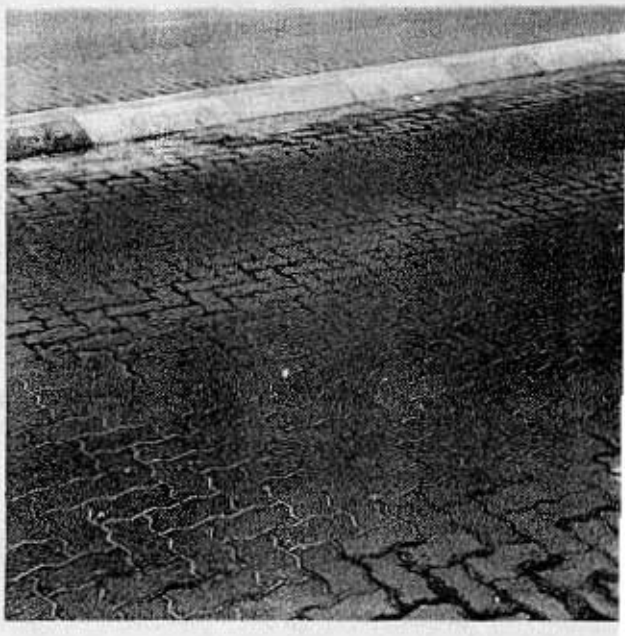
In contrast to the above solution, a new solution using concrete block paving of 8cm Uni-type laid in a herringbone pattern, performed successfully. These blocks were laid after removing about 20cm of the existing pavement, using a new thin subbase course and a 3cm sand course, (see Figures 5 6 and 7).

Figure 5. View of the rehabilitate junction with interlockin blocks.

Figure 6. Close-up photograph of interloc ing blocks.

Figure 7. Close-up photograph of a successful joint solution between interlocking blocks and the existing asphalt surface.

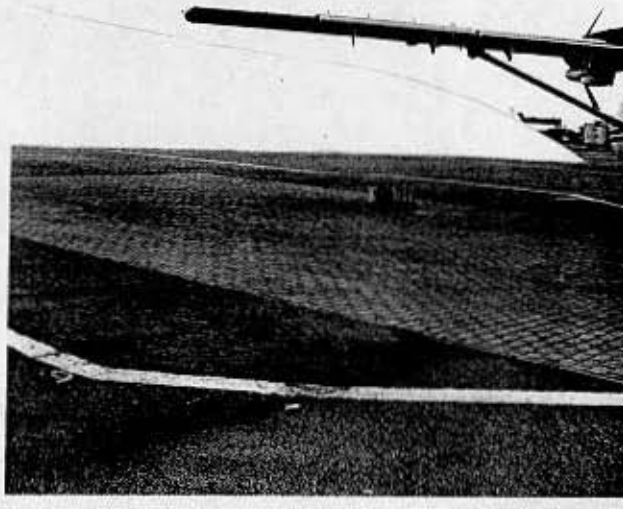
Figure 12. View of aircraft wash area.

This airport is built on expansive clays, an the expansion damages in this airfield ar not inconsequential.
