AN EVALUATION OF TYPICAL CONCRETE BLOCK PAVEMENT FAILURES IN SOUTH AFRICA

Concor Technicrete (Pty) Limited

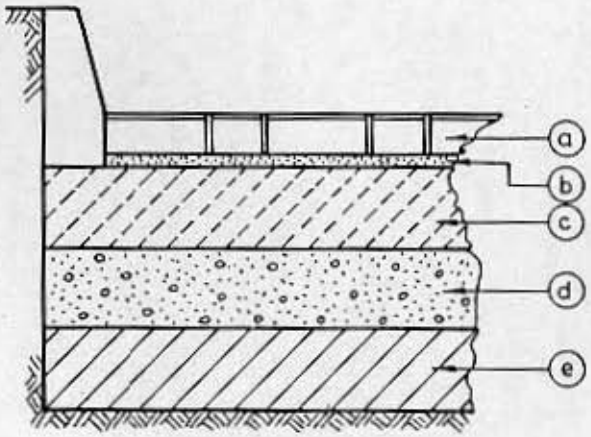
Figure (1) Extent of Failure

Work was completed in November 1986 and so after the "truck inn" was opened to traffic t paving started showing signs of failure, whi very rapidly deteriorated beyond acceptab norms.

The mode of failure were typical and includ inter alia

i) Rutting where traffic is concentrated alo specific routes, particularly in areas whi were subjected to high traffic volumes.

ii) Chipping and spalling of the pavers in op areas where vehicles turn and manouvre.

iii) Elastic deformation of the surface under the wheel loads.

iv) Rotation and subsequent creep of the blocks in the badly affected areas.

v) Opening up of joints thus destroying shear transfer between the blocks.

However the standard of workmanship in co structing the sub-surface earthworks was bel even marginal limits. This together with t inferior materials used in the fill under t pavement and further aggravated by the fa that no sub-surface drainage was allowed fo resulted in a complete breakdown of the int grity of the pavement.

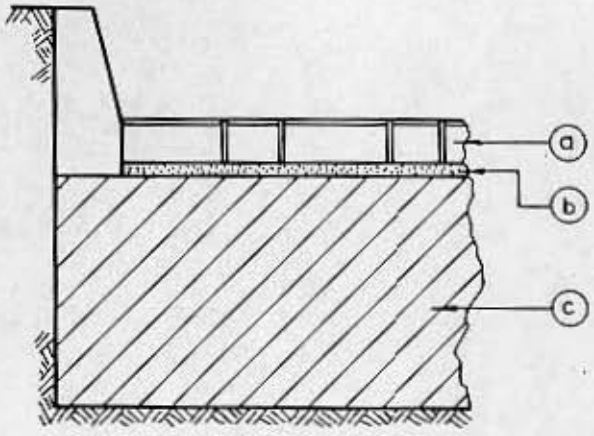
TABLE 1 - COMPARISON BETWEEN SPECIFIED AND CONSTRUCTED CRITERIA.

AS SPECIFIED	AS CONSTRUCTED

a) 80 mm interlocking concrete pavers
b) 25 mm bedding sand
c) 150 Stabilized natural gravel sub-base compacted to 95% mod AASHTO
d) 150 selected natural gravel sub-base layer compacted to 93% mod AASHTO
e) 150 mm thick in-situ sub-grade material scarified and re-compacted to 93% mod AASHTO

a) 80 mm interlocking concrete pavers
b) 20 mm bedding sand
c) Moist light grey, dense micaceous slightly clayey fine sand-fill. Compacted to 93% mod AASHO

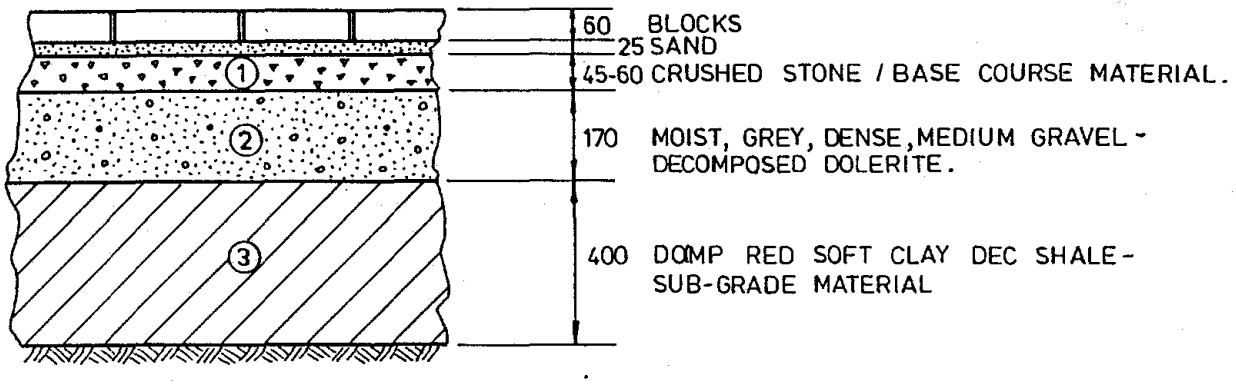
Figure (4) - Typical profile of test hole

To investigate the settlement which had taken place five test holes were excavated at the site and a typical profile (section) of the side of the test hole, is shown in figure 4.

An examination of this profile revealed that the re-establishment of the base course had not met the minimum thickness of 100 mm specified and it was concluded that this had contribut to the surface distortion that had taken plac

Table (3) - Results of Laboratory tests on various layers (see figure 4).

(i) Blocks uplifted and removed from site.
(ii) Existing base coarse material removed.
(iii) A 100 mm thick layer of crusher-run (base coarse) relaid, and compacted to 98% mod AASHTO.
(iv) 25 mm layer of bedding sand imported.
(vi) New 60 mm coloured blocks, manufactured in accordance with CMA specifications, laid.
