PAVEMENT REHABILITATION WITH CONCRETE BLOCK PAVING: A CASE HISTORY

Moshe Livneh, Karl Ruhm and Noam A. Livneh
Harry Oppenheimer Professor of Engineering, Transportation Research Institute, Technion, Haifa, Israel, Chief Highway Transportation Planning Engineer, Ministry of Housing, Jerusalem, Israel, and Research Engineer, Haifa, Israel, Respectively.

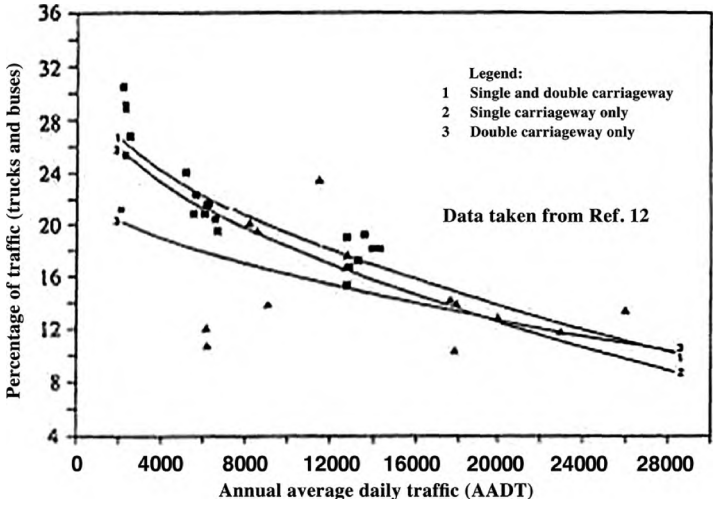
Fig. 3: The relationship between percentage of heavy traffic (trucks and buses) and inner-urban AADT.

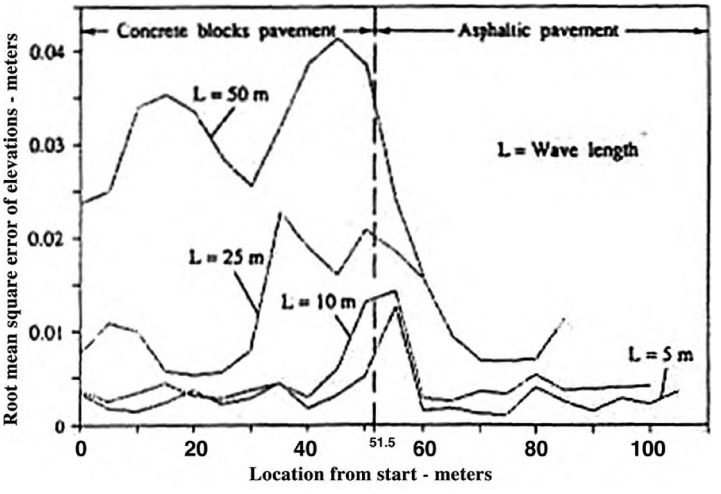
Fig. 4: RMSE of elavations as a function of the wave-length across both the asphaltic and concrete blocks pavements.

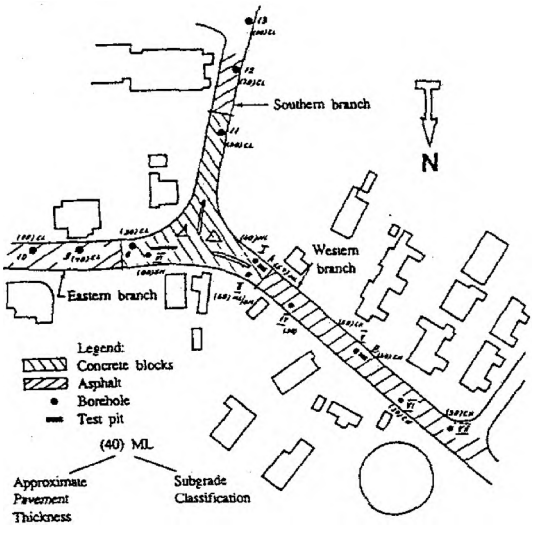
Fig. 5: Layout of boreholes and pits.

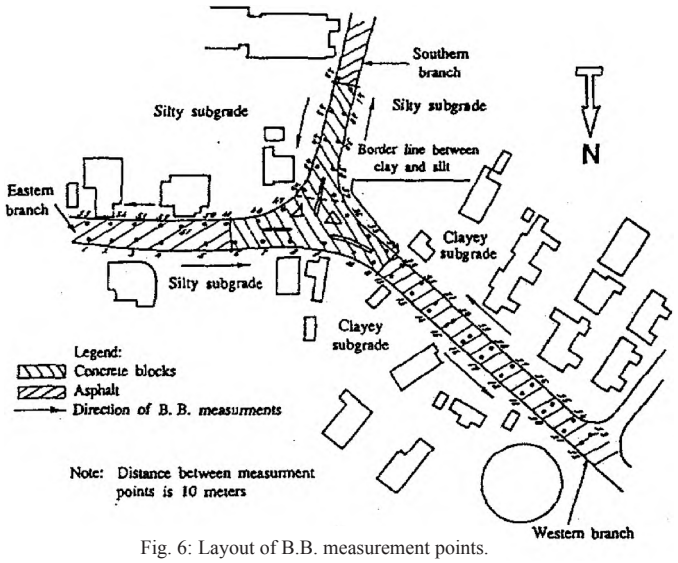
Fig. 6: Layout of B.B. measurement points.

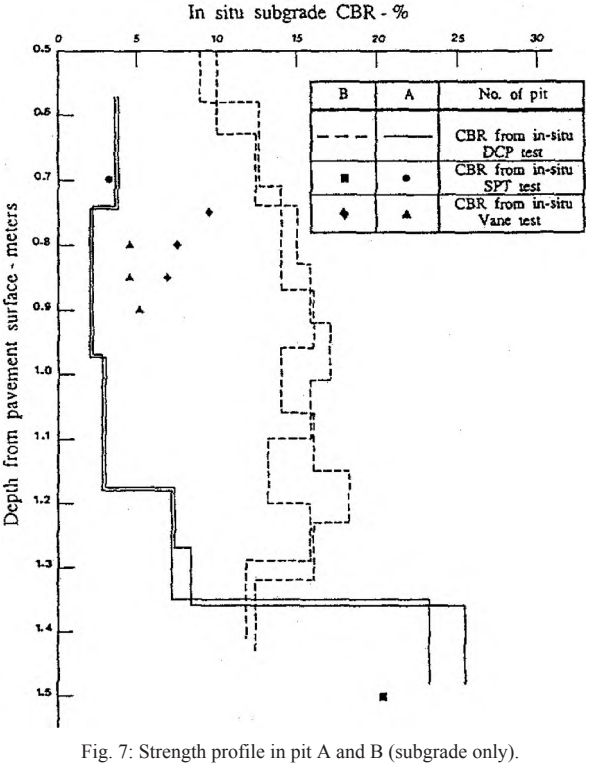
Fig. 7: Strength profile in pit A and B (subgrade only).

therefore stronger. It is important to emphasize that the subgrade strength in a direct surface test attains the highest value at the greatest depth in which the effect of confinement is already noticeable. By comparison, the variation in CBR values found in pit B {Fig. 10) is essentially negligible as the subgrade is comprised of clayey material less effected by confinement. [11]

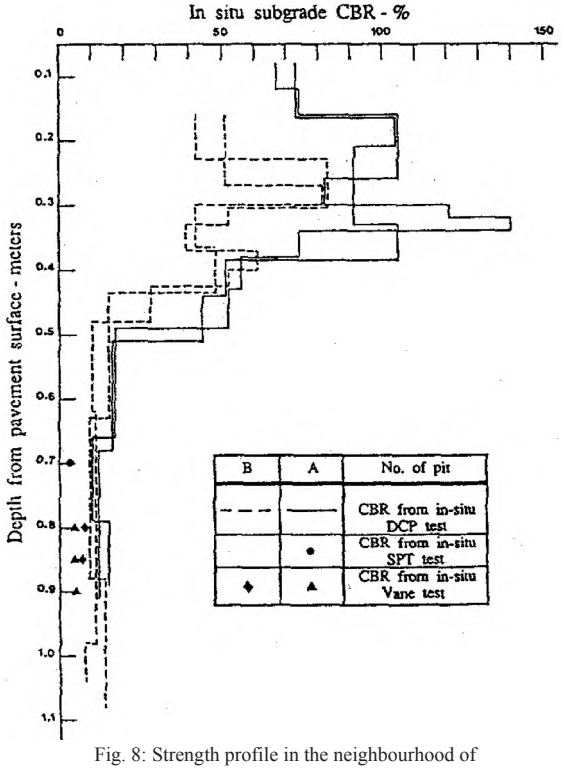
Fig. 8: Strength profile in the neighbourhood of pits A and B (including pavement layers).

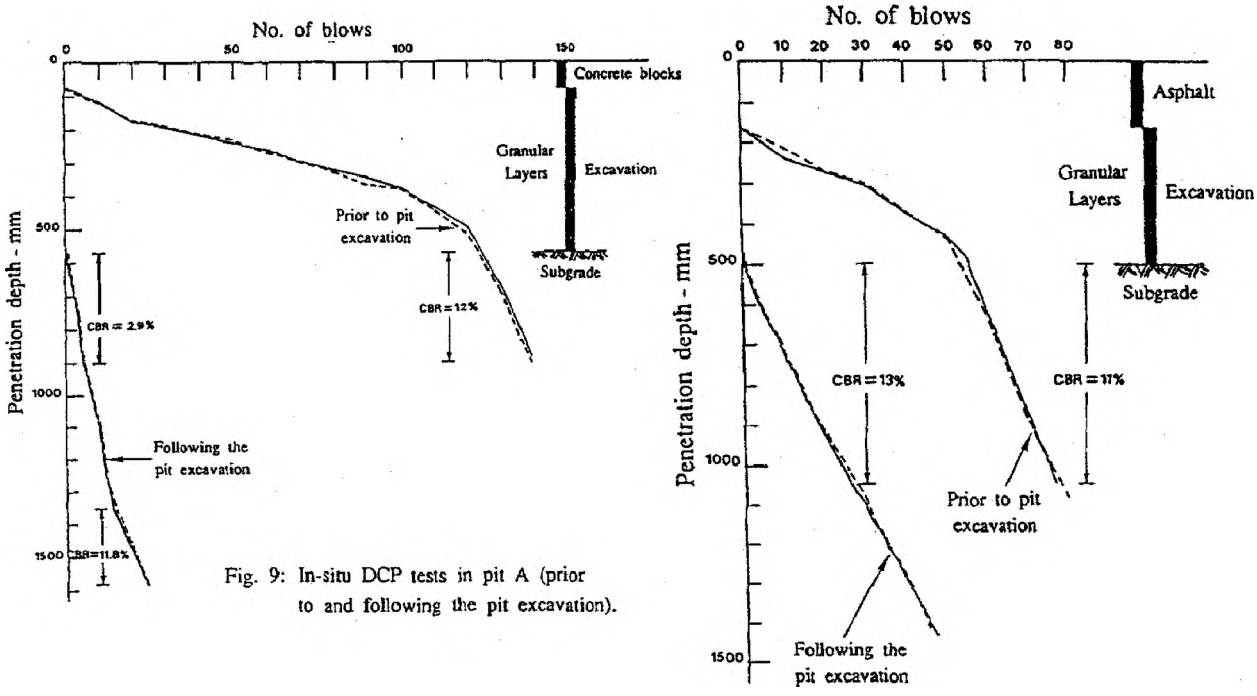
Fig. 9: In-situ DCP tests in pit A (prior to and following the pit excavation).

Fig. 10: In-situ DCP tests in pit B (prior to and following the pit excavation).

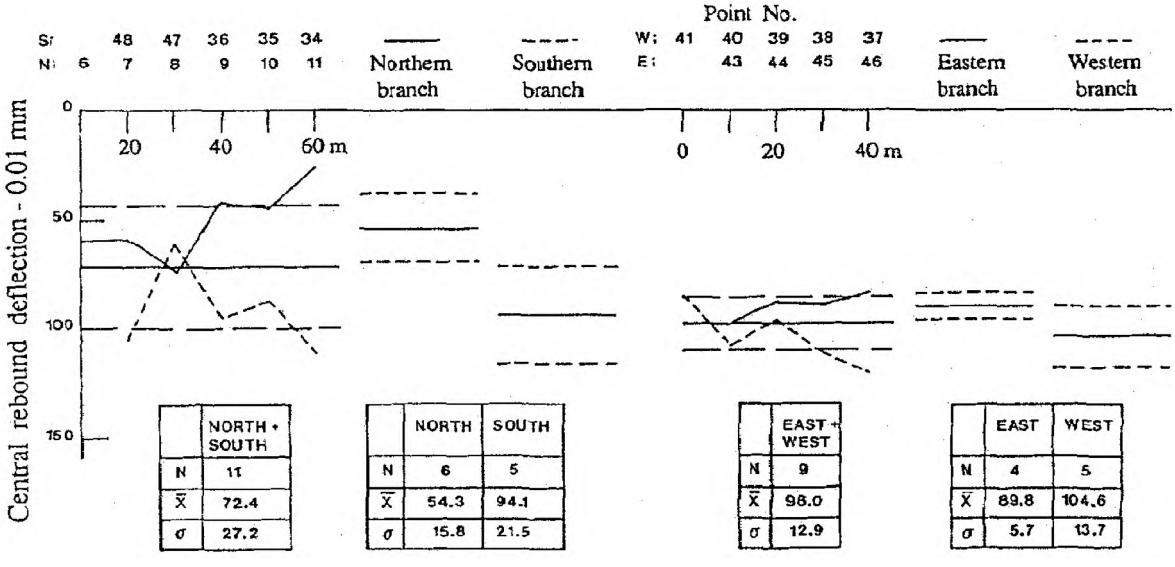
Fig. 11: B.B. central rebound deflections in the concrete blocks section.

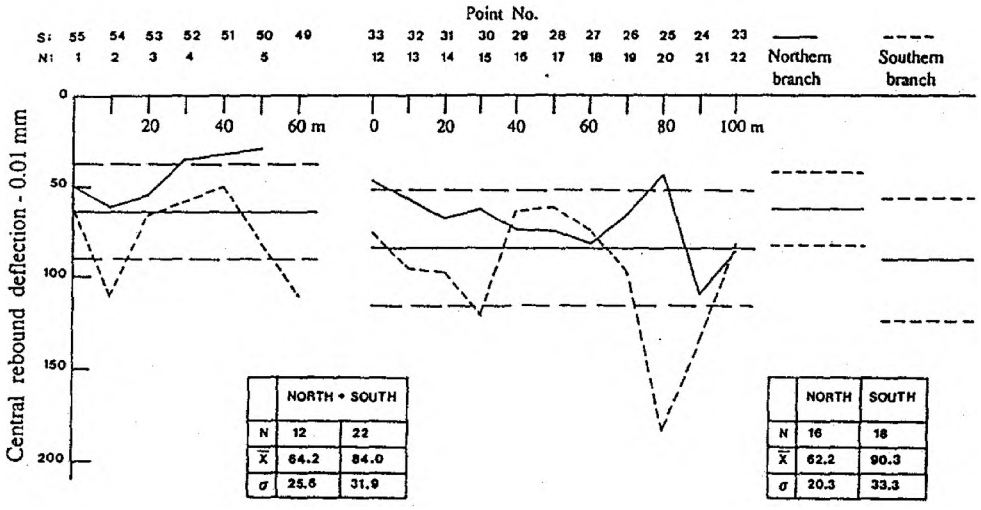
Fig. 12: B.B. central rebound deflections in the asphaltic section.

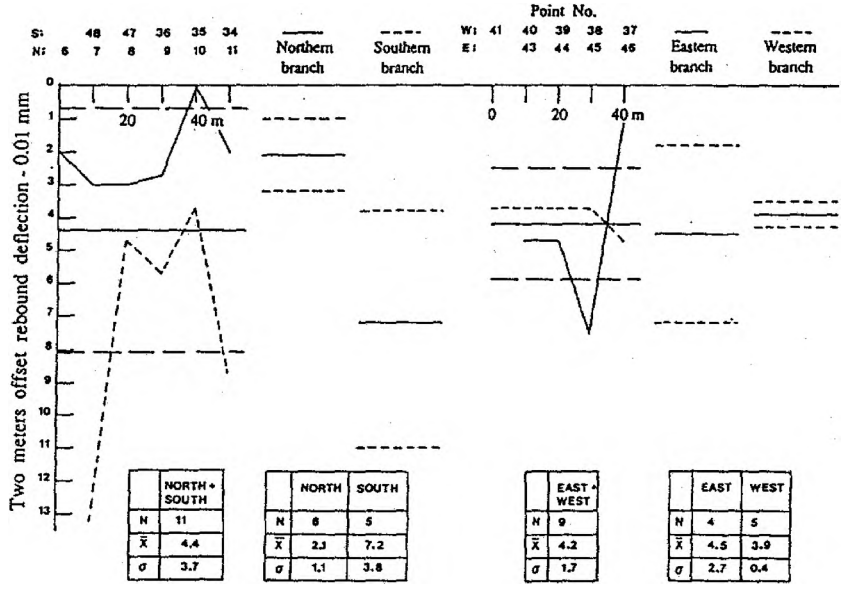
In a similar way, Fig. 1Z and Fig. 14 illustrate the rebound deflection at a distance of two meters from the truck's dual wheels. Basically, this deflection expresses the strength of the subgrade. According to these figures there is no essential difference between the subgrade strength of the concrete block pavement and the subgrade strength of the asphalt pavement.

Fig. 13: B.B. 2.0 meters offset rebound deflection in the concrete blocks section.

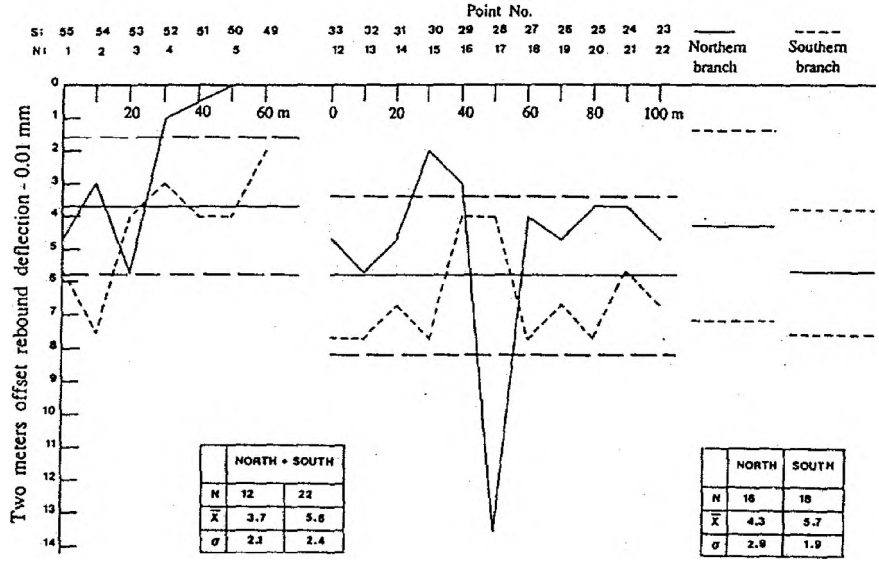
Fig. 14: B.B. 2.0 meters offset rebound deflections in the asphaltic section.
