LAYING COURSE SAND FOR CONCRETE BLOCK PAVING

A.A. Lilley, M.Phil., C.Eng., MICE, FIHT - Consulting Engineer
A.J. Dowson, B.A., T.Eng.)C.E.I.), M.I.G., Tech.E.

MARSHALLS MONO LIMITED

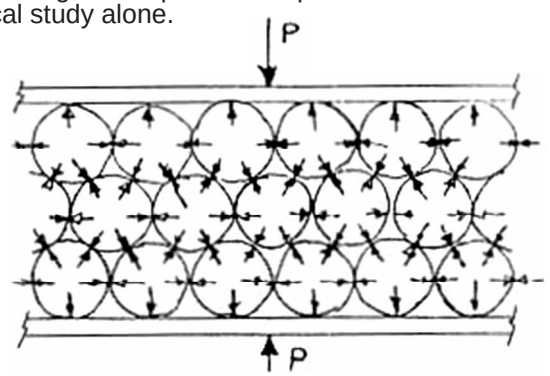
PARTICLE GRADING AND SHAPE: Consider a uniformly graded material made of spherical particles; high contact loads will be developed, as illustrated in Figure 2. It can be shown that if the particle diameter is halved the number of contact points will increase on a square law and therefore the load at individual contact points reduced in a similar proportion. From this it is implicit that fine sand is preferable.

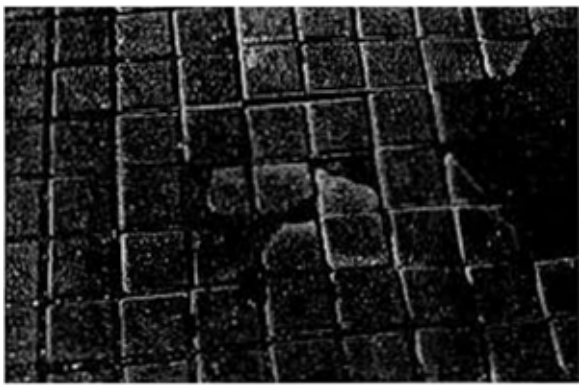
Figure 4 is a close view of one of the depressions, showing typical opening of the joints.

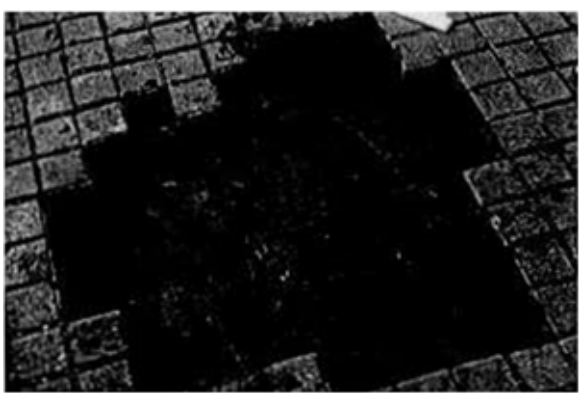
A specific appearance of the joints associated with this type of failure is fine sand extruding from the joints (Figure 5) and/or in most instances staining around the edges of the blocks, as shown in Figure 6.
