BEDDING COURSE SANDS

Ian D. Cook, Technical Director, Blockleys Brick Limited
Dr. John Knapton, Managing Director
John Knapton (Consulting Engineers) Ltd

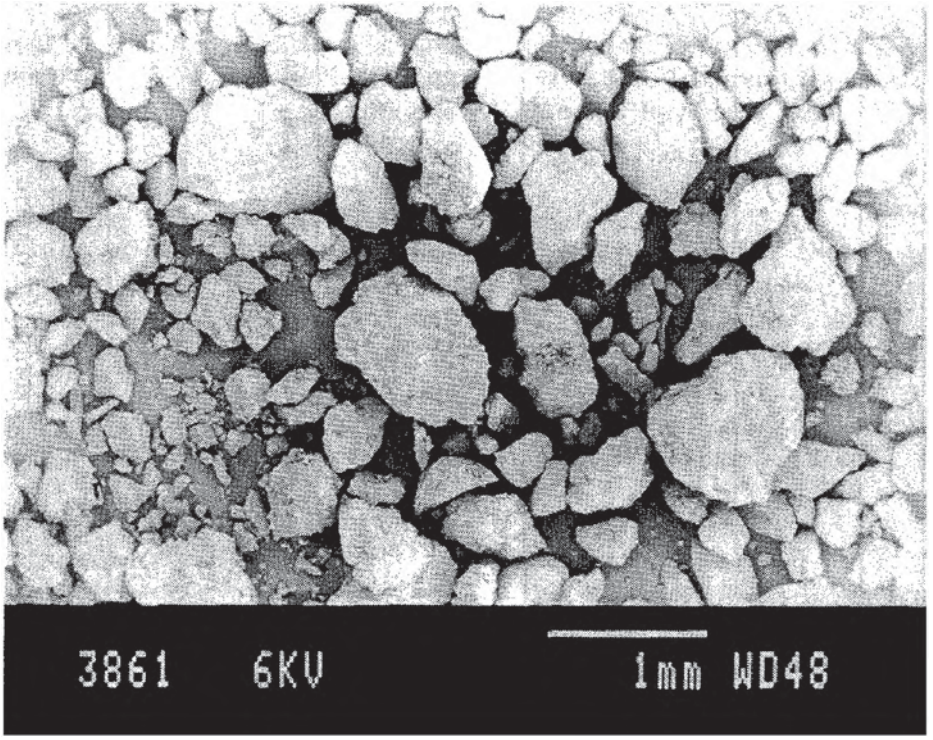
CRUSHED ROCK MICROGRAPH

In common with the project in Seattle an analysis of failed pavements in the North West of England revealed that 'crushed rock' sands and not naturally occurring sands had been used. It appeared that under the action of heavy channelised traffic; such as that found in bus stations, the individual grains of crushed rock sands broke down into a fine dust. This, in the presence of water migrating through the bedding course layer, formed a lubricating slurry which was considered to be the principal cause of pavement failure. Micrograph analyses of crushed rock sands revealed that they have sharp features which can become dislodged when individual grains of sand are caused to rub against each other in pavements which receive heavy channelised trafficking (Figure 1). In service the grains break down into smaller and smaller particles and the sand effectively degrades itself.

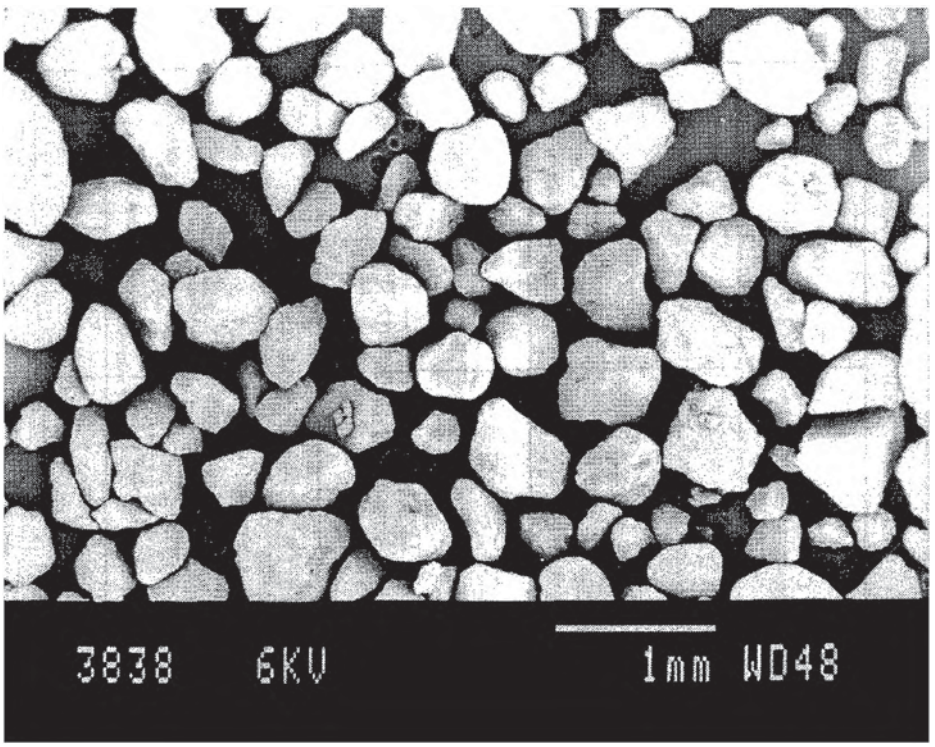
SILICA SAND MICROGRAPH

An assessment of schemes that have performed satisfactorily in critical situations such as bus stations indicated almost exclusively that naturally occurring silica sands had been used.
