A SURVEY OF AUSTRALIAN CONTAINER PORT PAVEMENTS SURFACED WITH CONCRETE SEGMENTAL PAVING

Shackel, B., Pearson, A. and Holt, W.

School of Civil and Environmental Engineering, University of New South Wales, Queensland, Australia.

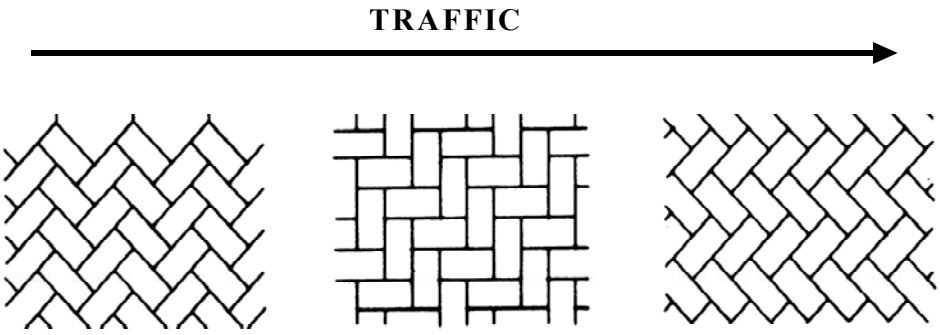
Figure 1. Orientation of herringbone pattern relative to traffic with (a) best and (c) worst.

This study suggests that there is a need for designers to be encouraged to give more attention to the orientation of herringbone laying patterns when very heavy wheel loads such as those applied by transtainers are to be carried. As noted above, a common situation is that the mode of operation may change after the pavement enters service e.g. from FLT movements to straddle carrier operations. In such cases, where a change in operation mode may occur, it would be best to choose Pattern (b) in Figure 1 rather than the more optimal pattern (a).

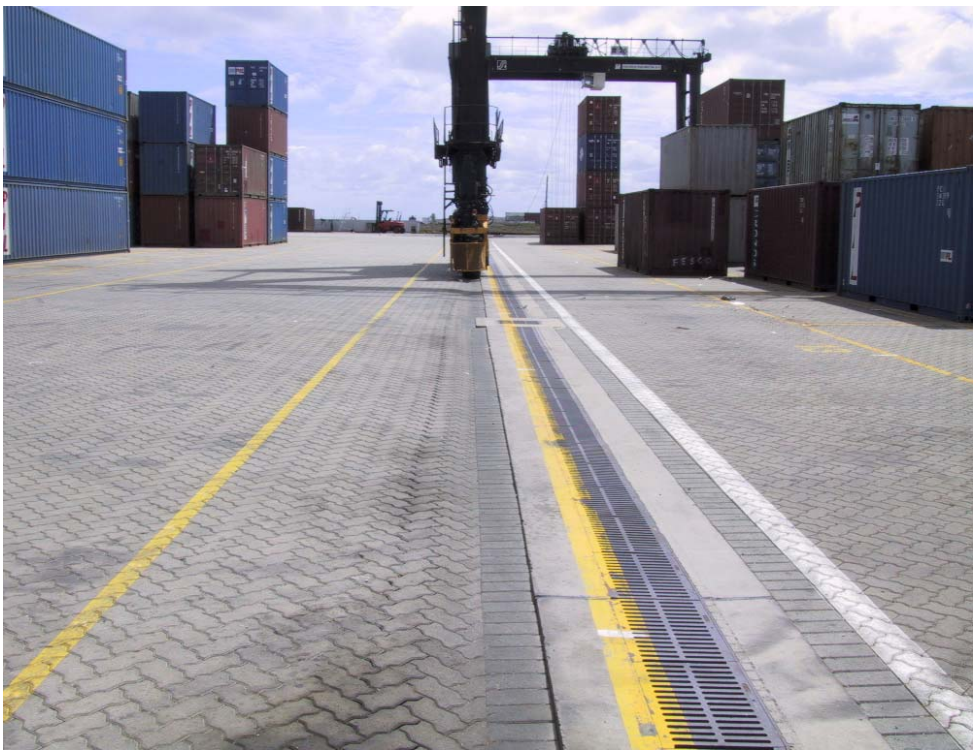
By referring to Figure 1 it may be seen that, for the pavement shown in Figure 2, the orientation of the herringbone pattern to the left of the drain with respect to the dominant direction of trafficking was the least advantageous possible. Here, rotation of the bond through 90º would have acted to reduce rutting under traffic caused by the transtainer. Inconsistently, the pattern show to the right of the drain in Figure 2 is optimally aligned for transtainers or straddle carriers moving along the container rows. Although the pavements were not specifically designed for transtainer operation this demonstrates the need to take care when establishing the orientation of laying patterns during design and construction and is discussed further below.

Figure 2. Pavement to right of drain is optimally orientated for straddle carriers whilst pavement to left is sub-optimal for the transtainer movements.

Soldier courses of rectangular pavers have also been used along slot drains and at yard entrances. Sometimes this has caused problems. For example, as shown in Figure 2, the soldier course may be seen to have been installed along the wheel path of a transtainer. This cannot be considered a good detail because, as noted above, it is documented (e.g. Shackel, 1990) that both rectangular pavers and stack bonds are associated with poor performance under traffic. Consequently pavers in the soldier course rotate and creep under traffic. Overall, based on this study it must be concluded that the use of pavement details developed for roads are not generally suitable for industrial pavements and more specific details need to be redesigned
