ATTACHMENT TO PAPER 'TESTING OF CONCRETE BLOCK PAVEMENTS BY THE AUSTRALIAN ROAD RESEARCH BOARD'

K.G. Sharp and P.J. Armstrong, Australian Road Research Board, Australia

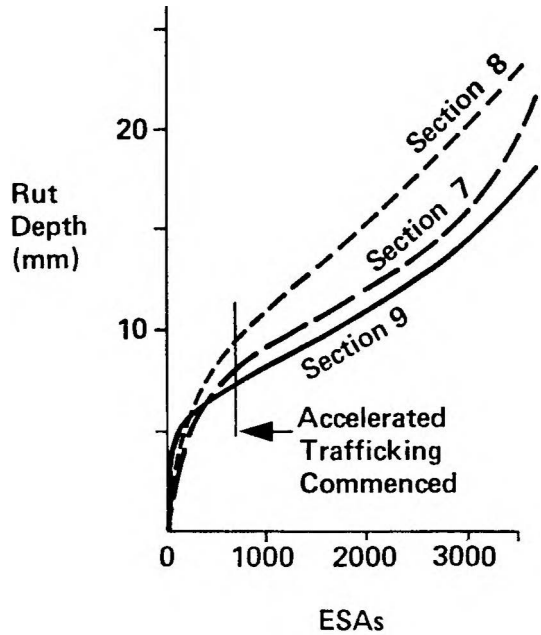
Since publication of the above paper in the Conference Proceedings, testing of Sections 7, 8 and 9 (see table 2 of the paper) has concluded. The development of rutting on these sections is shown in figure 1 of this attachment. It can be seen that all pavements had failed after 3500 ESAs. Figure 5 of the paper had indicated that, after 300 ESAs, Section 7 (composed of Unidecor blocks - see figure 3 of the paper) was performing as well as Section 9 (composed of Unipave blocks). Figure 1 of this attachment indicates that there was little difference between the performance of the two shapes, but as all pavements failed it is difficult to draw any conclusions regarding the relative performance of the two block shapes.

Figure 1. Rut depth vs. ESAs for test sections 7, 8 and 9 at ARRB.

The performance of Sections 7 - 9 was in line, from a pavement life viewpoint, to the T1 curve of the Australian design guide for block pavements (see paper) and the suggested ranges of traffic. This suggests that for a range of subgrade CBRs 2 to 4 the T1 curve should be located in the position currently occupied by the T4 curve.
