9th. International Conference on Concrete Block Paving. Buenos Aires, Argentina, 2009/10/18-21
Argentinean Concrete Block Association (AABH) - Argentinean Portland Cement Institute (ICPA)
Small Element Paving Technologists (SEPT)

CASE STUDY FOR THE GOOD LONG-TERM SERVICEABILITY OF INTERLOCKING BLOCK PAVEMENT

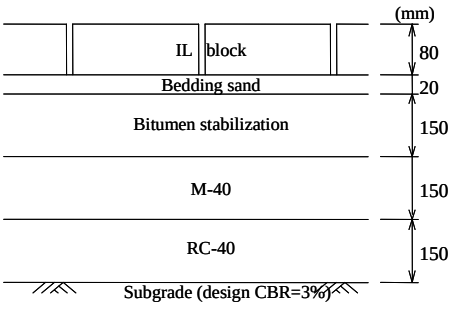
Figure 1. Pavement structure

As shown in Figure 1, bitumen stabilization was used for base course and the design of traffic volume was N5 (number of commercial heavy vehicle 250~1000 /day-direction). The design CBR of subgrade was 3%. The road surface condition of IL block pavement was comparatively sound at the sections from near the terminal entrance to cornering region of taxi bay and bus stop as shown in Figure 2 and Figure 3. However, rutting occurred partially in the cornering region of taxi bay and bus stop, and a spout of joint sand and bedding sand due to the settlement and pumping was observed as shown in Figure 4 and Figure 5.

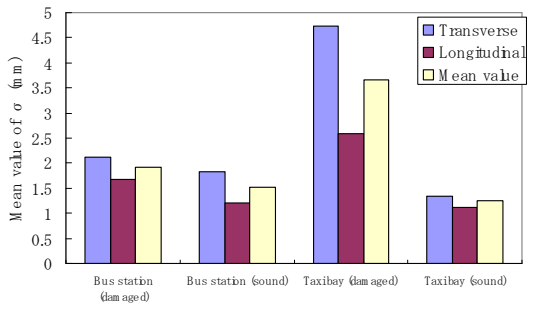
Figure 6. Results of roughness σ.

Figure 2 indicates the mean value of measured roughness. It can be seen that roughness at taxi bay in the damaged section is deteriorated due to the effect of rutting. However, all results are less than the JIPEA maintenance standard of 5 mm. Therefore, the roughness was sound condition.

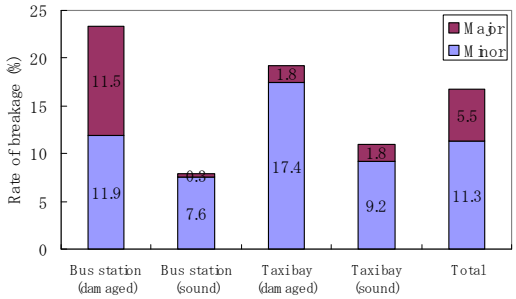
Figure 7. Results of rate of block breakage.

Results from the investigation of block breakage are shown in Figure 3. The rate of block breakage at bus station of damaged section was more than 20%, which is JIPEA maintenance standard value.

Otherwise, the rates of block breakage at other sections were less than JIPEA standard criteria. There exists 11.3% of minor broken edges and 5.5% of major broken edges. No major breakage was observed. Overall, it was sound condition.

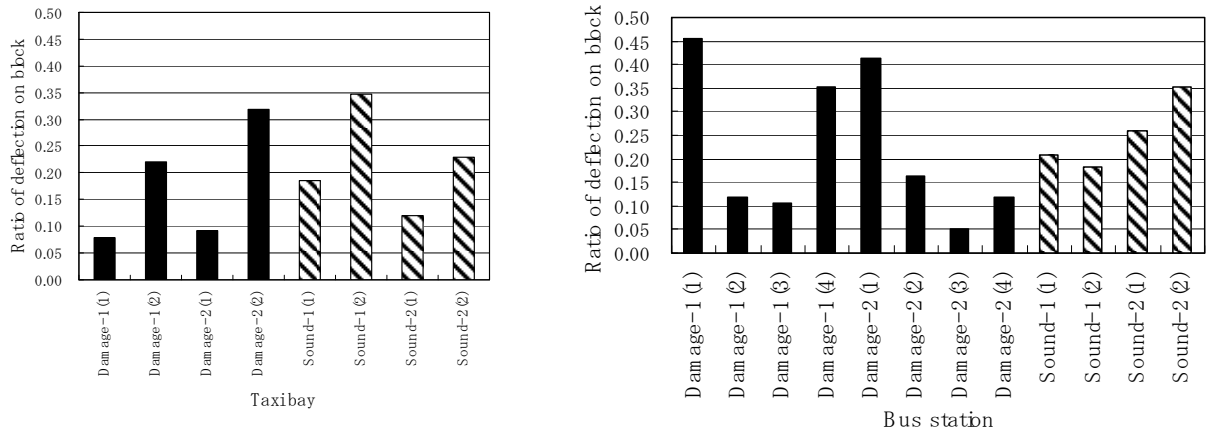
Figure 8. Results of ratio of deflection of block.

Figure 4 indicates the ratios of deflection measured at IL block surface, and Figure 5 shows the modulus of deflection measured at base course by HFWD. In the Figure 4, it can be seen that some ratios of deflection are large in the damaged section. However overall, the ratios of deflection in the sound section are larger than those of damaged section. In Figure 5, all modulus of deflection of base course are larger than JIPEA standard criteria (upper N4 in normal roadway and upper 730 MN/m^2), except the one from the taxi bay of damaged section. Based on the modulus of deflection, although the load transfer efficiency varies due to the effect of joint width, the bearing capacity was strong enough.

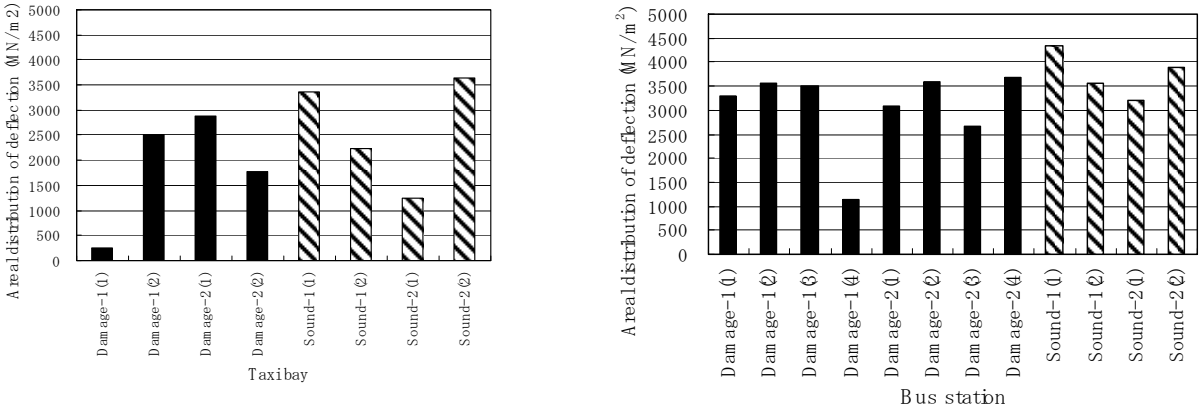
Figure 9. Results of modulus of deflection of base course.

- The modulus of deflection of base course near the taxi bay where the rutting was observed did not satisfy the JIPEA maintenance standard value. However, other 7 sites significantly satisfied the standard value. Overall, this site had strong enough bearing capacity. Additionally, even though the bedding sand consisted of lower quality of pulverization than the current standard value, the thickness was in excellent condition.

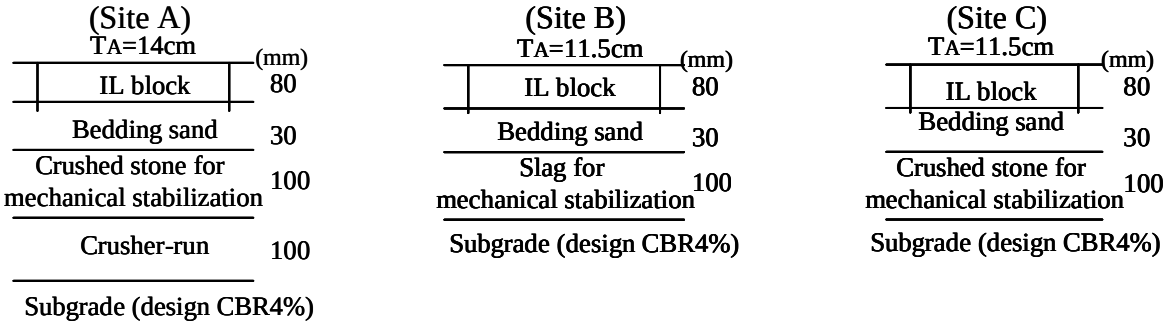
Figure 6. Pavement cross section.

Investigation was conducted at the roadway in shopping street that was built on March 1981 in the city of Osaka. The pavement was wavy rectangular IL block (111*225mm) with thickness 80mm that was laid in a 45°herringbone bond pattern. As shown in Figure 6, three different types of pavement were employed for investigation. The design of traffic volume was N3 (number of commercial heavy vehicle less than 100/day-direction), and the design CBR of subgrade was 4%. According to the current design standard, the pavement design of site B and C are currently lack of enough T_A.

The surface conditions of IL block pavement at three sites are shown in Figure 6. In a whole are of 642 m^2 at site A and B, there were repair marks in about 250 m^2 repaired by new material. This was due to the restoration construction (water service and drainage), but not the repair with the pavement distress. As long as visual survey, there was no significant damage. The surface condition was excellent.

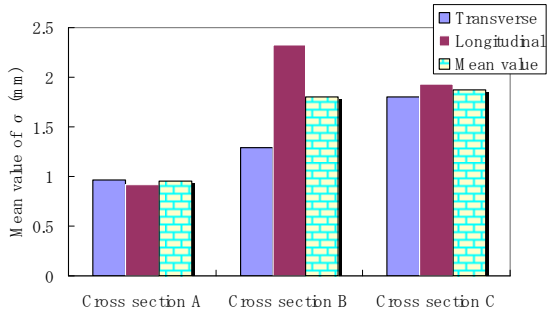
Figure 7. Results of roughness σ

Results of the mean value of roughness are shown in Figure 7. As shown in this figure, the minimum value occurred in site A whose base course thickness is thick. All results satisfy the JIPEA maintenance standard value of 5 mm. Thus, as long as roughness, the condition was excellent.

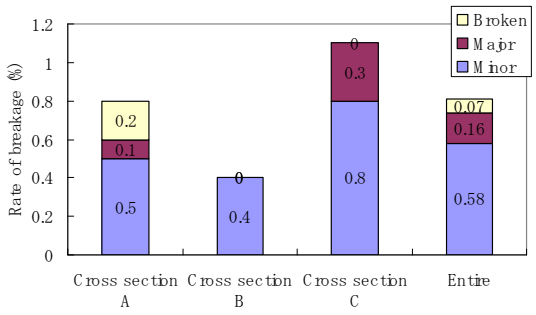
Figure 8. Results of rate of block breakage

Results of rate of block breakage are shown in Figure 8. As shown in this figure, all results satisfy the JIPEA maintenance standard value 20%. The damages are only minor broken edges. Thus, as long as the rate of block breakage, the condition is excellent.

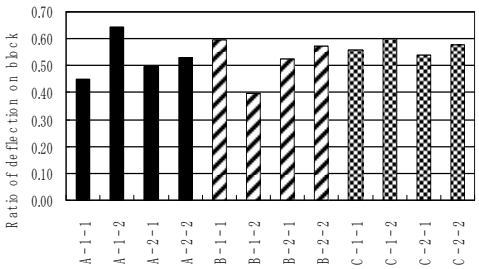
Figure 9. Results of ratio of deflection of block.

Figure 9 indicates the result of the ratio of deflection of block surface measured by handy FWD. As shown in this figure, all ratio of deflection in 3 sites are almost all the same. Hence the effect of load distribution by IL block is excellent. Additionally, by comparing with the above-mentioned results in bus terminal, these ratios of deflection are larger than those of above-mentioned. Hence, the effects of load distribution are larger.
