WEBB DOCK CONTAINER TERMINAL PAVEMENTS TEN YEARS ON

Douglas O. Oldfield

Senior Engineer, Maunsell Pty. Ltd., Melbourne

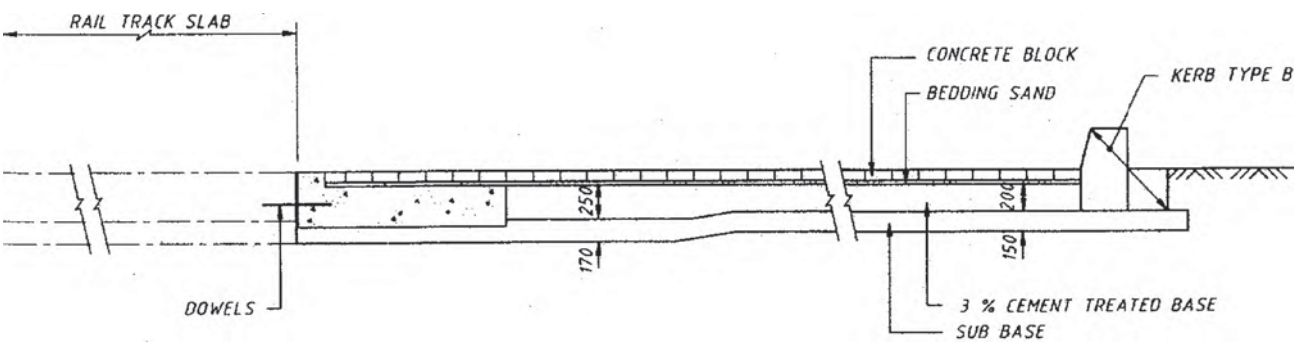
Figure 3 Rail Terminal Pavement Details

Nowhere in the terminal's concrete segmental pavements is there any evidence of rutting or other movement which might indicate onset of failure. The surfacing is well sealed and no penetration of rainwater run-off through the pavers is apparent. Minor problems have arisen at some locations in the pavements. In particular, settlement at structures continues to be a problem, especially at the pavement/wharf deck interface and to a lesser extent at the deep drainage pits. This problem is, of course, a consequence of settlements in the subgrade and the underlying fill and is not attributable to the use of concrete segmental pavers as the surfacing medium. The effects of settlement have been better catered for in the Rail Terminal by incorporating a special run-on slab detail (Figure 3), which has also more recently been adopted at pavement/wharf interfaces on other projects.

(iv) positive measures in the Rail Terminal pavement to overcome the problems associated with differential settlement, which had become evident in the No. 5 Terminal pavement.
